Manhole Inspection Summary

Manhole # S11AA2020MH

Insp Date: **9/27/06 2:44 PM**

Location Address: **5726 GREENSPRING AVE**

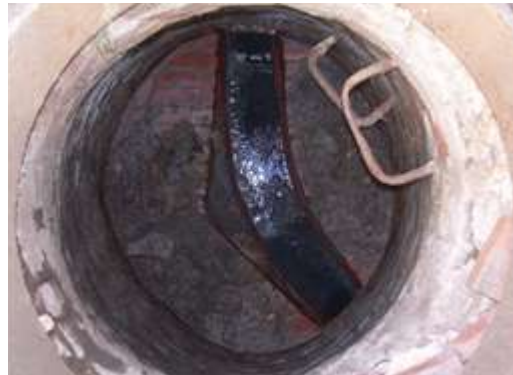
Top View

Corroded steps. Evidence of surcharge - Bench debris. Channel debris.

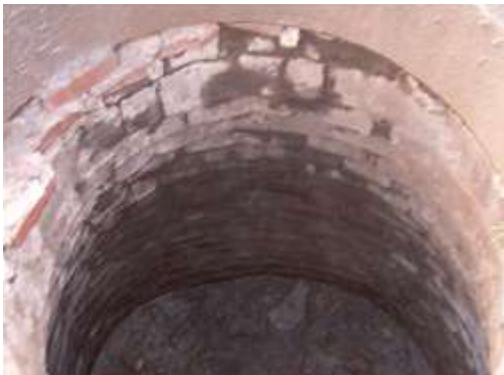
Defect

Frame Offset: **2** (in.) Condition: ☐ Sound ☐ Cracked ☒ **Leaks**

Condition: ☐ Sound ☐ Cracked ☐ Root Intrusion ☒ **Loose Brick** ☒ **Deteriorated**

Infiltration: ☐ None ☒ **Joint** ☐ Cracks ☒ **Mortar** ☐ Roots ☐ Wall

Frame leaks. Adjustment deterioration and infiltration. Corbel and Barrel infiltration.

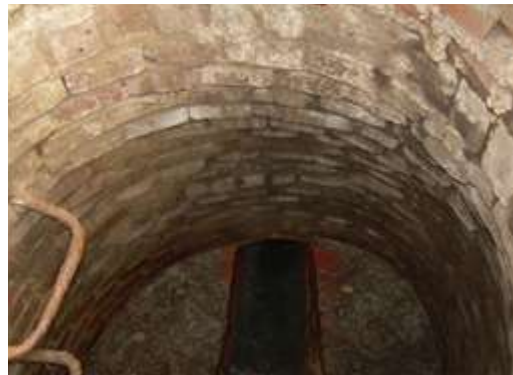
Defect

Infiltration: ☐ None ☐ Joint ☐ Cracks ☒ **Mortar** ☐ Roots ☒ **Wall**

Adjustment, Corbel and Barrel infiltration.

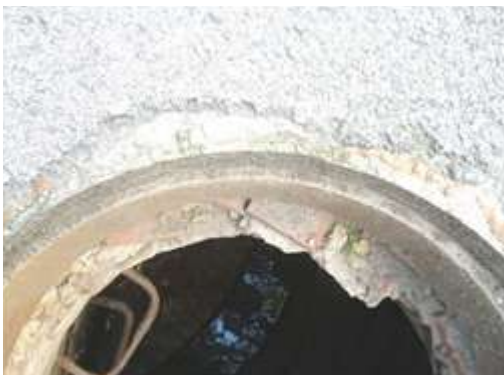
Defect

Frame leaks. Frame offset. Adjustment deterioration, loose brick and infiltration.

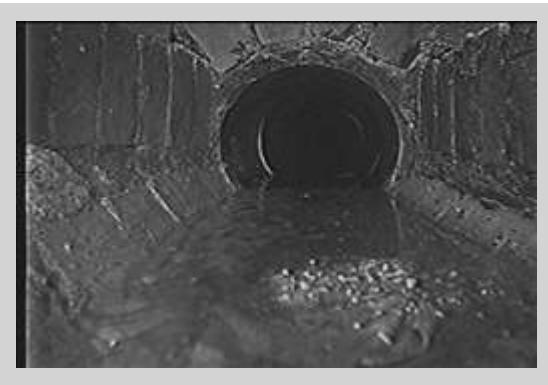
8 in. Circular Gravity Sewer Pipe Out @ 12 O'Clock

Channel deterioration.

Infiltration: **Evidence** Pipe Seal Cond: **Cracked**

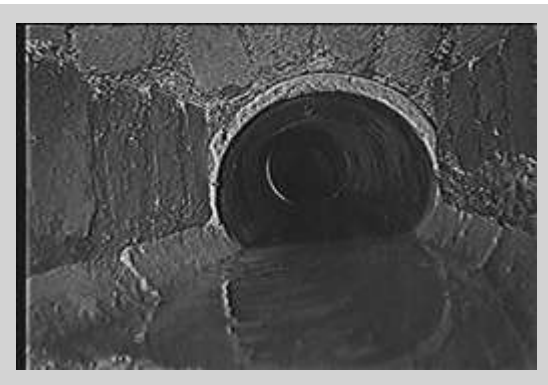
8 in. Circular Gravity Sewer Pipe In @ 4 O'Clock

Infiltration: **Evidence** Pipe Seal Cond: **Unknown**
